SIXTH ENDORSEMENT on VMA 324 AAR ser 13-55 concerning AD-48, 132339
accident occurring 13 Dec 1955. pilot RUSSEN

Subj: Aircraft Accident Report

1. DATE OF ACCIDENT 13 Dec 1955	2. HOUR 2211A	3. ACTIVITY SUBMITTING REPORT Marine Attack Sqd. 324	4. AAR SERIAL NO. 13-55
5. MODEL, A/C AD-4B	6. CHECK DAMAGE TO A/C 132339	7. REPORTING CUSTODIAN OF A/C Marine Attack Sqd. 324	8. OPERATIONAL GRADE OR COMMAND CVO-6, CO CVA-39, ComCarDiv 2
9. NAME OF UNIT OPERATING THE A/C Marine Attack Sqd. 324, USS Lake Champlain	10. BASED AT 40029°N 11016.5°E (At Sea)	11. NAME OF UNIT TO WHICH OPERATOR ATTACHED Marine Attack Sqd. 324	12. COMMANDER'S NAME ComSixthFt Comairant, NASC

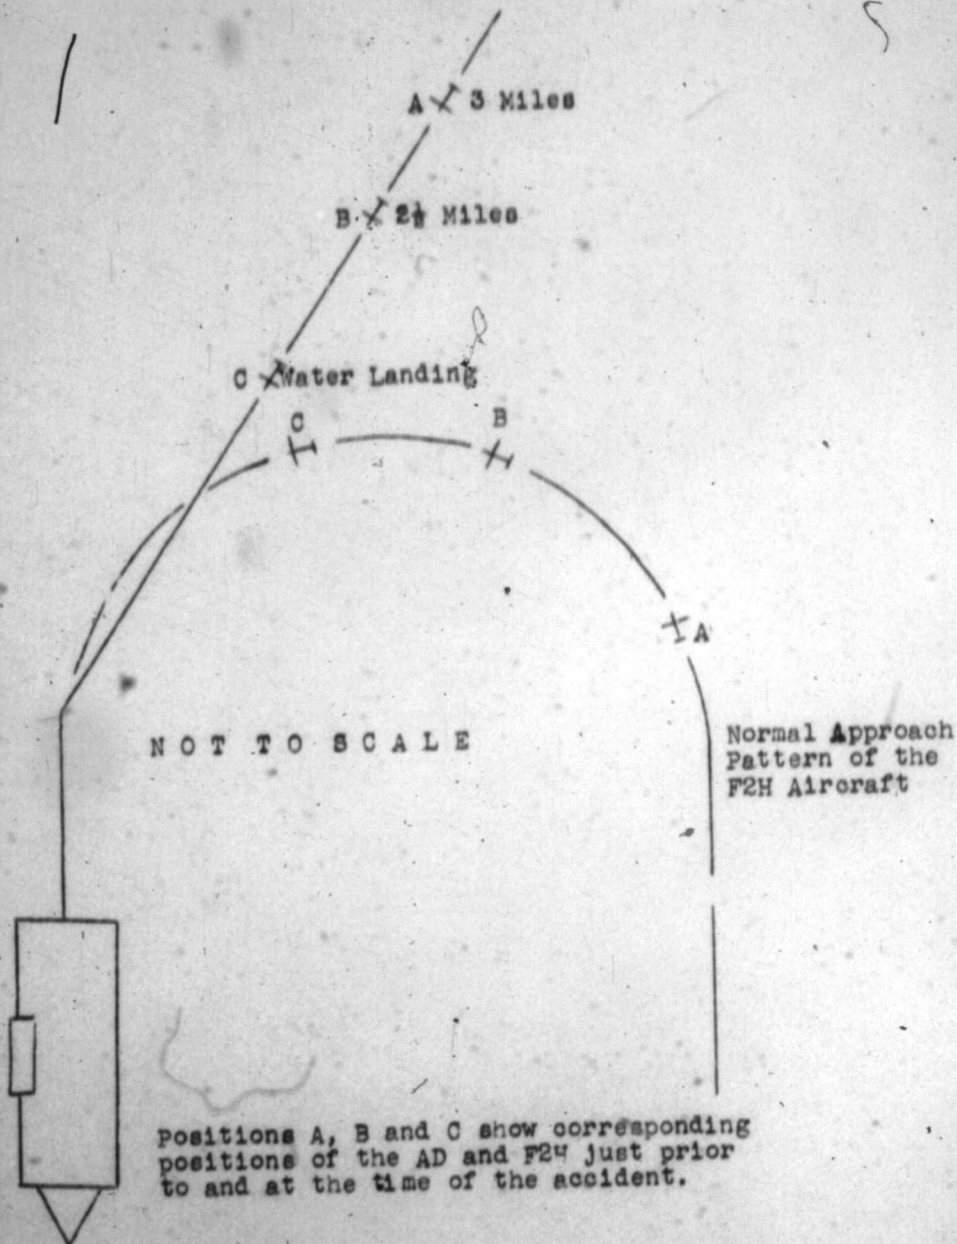
CCA Pattern of
the AD Aircraft

4. A system that combines the normal carrier approach and carrier controlled approach is an unsafe practice, (Refer to Encl (10) for sample CCA procedure) unless a definite procedure is established for giving one aircraft preference and waving off the other before the situation becomes dangerous.

1. Continuing emphasis be placed on the necessity of strict attention to flight instruments when instrument flight is being conducted.
2. Traffic control procedures be established to prevent occurrence of the conditions existing at the time of the accident. This would include an automatic wave-off for all aircraft within three miles on a CCA final approach when there is another aircraft inside of the 180 degree position on a normal approach.
